**Flood Control Project Maintenance
Levee Inspections**

Fall 2018 Levee Maintenance Deficiency Summary Report

Sacramento River Basin

Reclamation District No. 0554 Walnut Grove

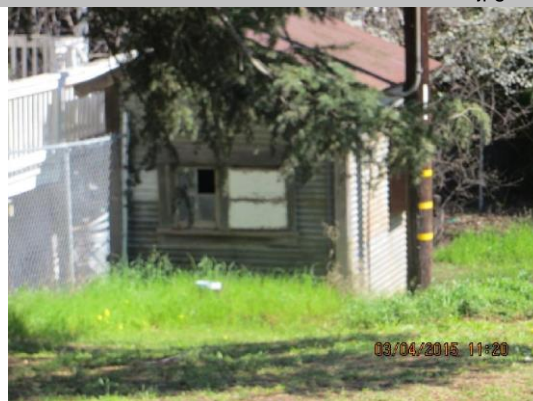
Photo 1 of 3 : UCIP_FA_2018_43726_73282.jpg

Comment Code					
Inspector Comment					
FS_ID:43726 DS_ID:18976 EP_NO: N/A Repair Type: Non-Urgent Crossing Status: Indicator Found UCIP Comments: Need to verify status of crossing with town of Locke. FIELD_STRUCT_DESC: 12-inch two water systems (a domestic and fire main) through the levee at unknown depth. Crosses levee just south of concrete block pumphouse on waterside (WS) shoulder and terminates at well house off landside (LS) toe. Gatevalve next to corner of pumphouse off LS toe. (12-inch pipe authorized under Permit No. 12944, 1980 - Sacramento Housing and Redevelopment Agency; transfer approval for Plans No. 12944 from Sacramento Housing and Redevelopment Agency to the Conty of Sacramento - Department of Public Works authorized under Permit No. 12944-A, 1982 - County of Sacramento Department of Public Works) FS Date: 3/4/2015 4:49:00 PM

Pumphouse off LS toe.

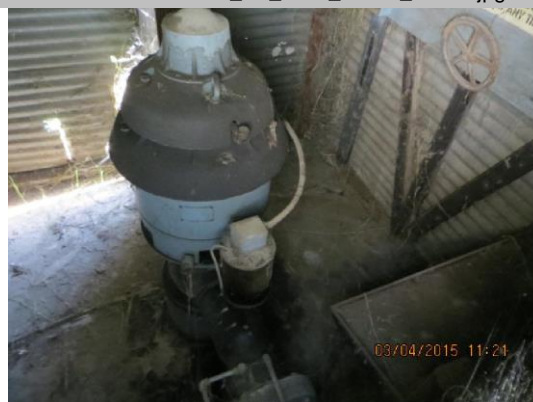
Photo 2 of 3 : UCIP_FA_2018_43726_73281.jpg

Pump over well inside pumphouse on LS toe.

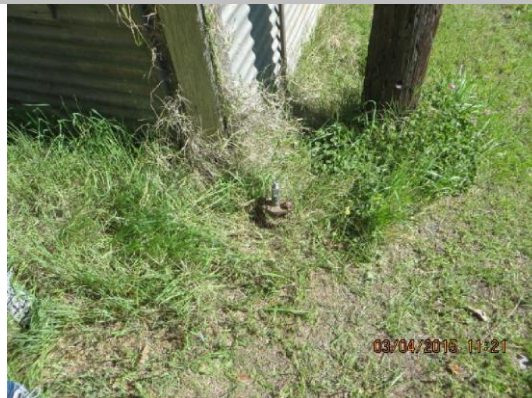
Photo 3 of 3 : UCIP_FA_2018_43726_73280.jpg

Gatevalve at corner of pumphouse on LS toe.

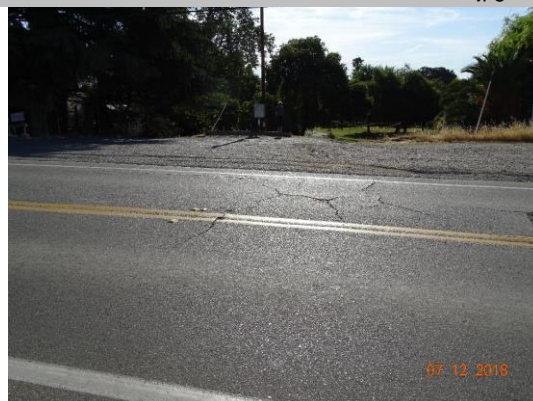
Photo 1 of 3 : UCIP_FA_2018_53405_77590.jpg

Comment Code						
Inspector Comment						
FS_ID:53405 DS_ID:20915 EP_NO: 3360 Repair Type: Non-Urgent Crossing Status: Not Found UCIP Comments: 07/12/2018 No gas line markers at the crossing found. Need to contact PG&E. Crossing has been downgraded to "Non-Urgent" due to reclassification of gas lines. (O.Yakimov-DWR UCIP)7/25/2016 Coordinated with District Engineer, Gilbert Labrie with DCC Engineering. He will investigate the pipe and coordinate with PG&E to find out additional information regarding the fate of the pipe. (DWR UCIP - omagana)3/04/2015 No markers found. Need to contact owner to determine status of crossing. Recommend having owner install markers per CVFPB Title 23 for active pressure line. Owner will need to coordinate with CVFPB. (DWR UCIP - omagana) FIELD_STRUCT_DESC: Gas line along and through the levee, 3.5 feet below the crown. (gas line authorized under Permit No. 3360, 1962 - Pacific Gas and Electric Company [PG&E]) FS Date: 7/12/2018 7:28:04 AM

View of levee crown at the crossing toward LS.

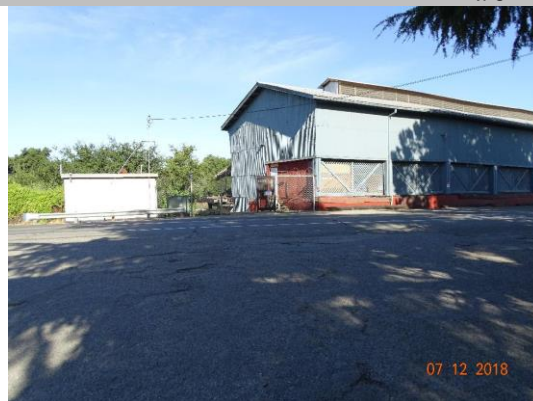
Photo 2 of 3 : UCIP_FA_2018_53405_77591.jpg

View of levee crown at the crossing toward WS.

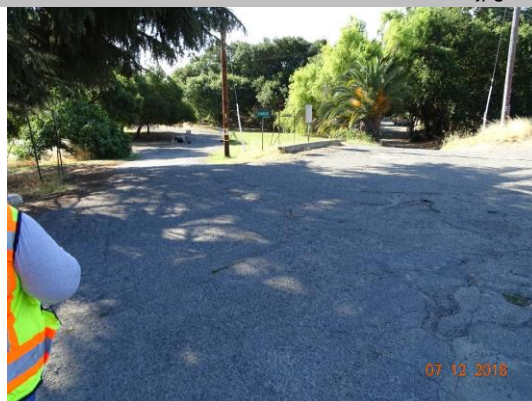
Photo 3 of 3 : UCIP_FA_2018_53405_77592.jpg

View of LS at the crossing.

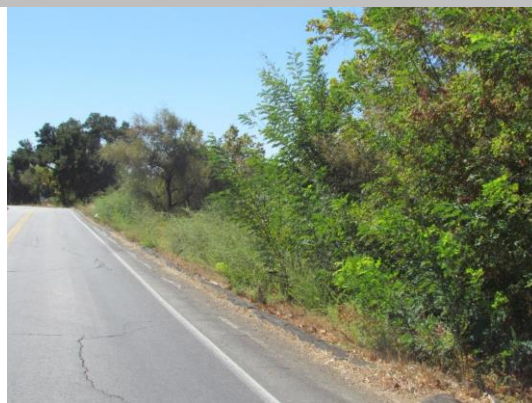
Photo 1 of 1 : FA_2018_RD0554_176_31_20180925_00007.jpg

LM Start	0.02	Rating **	U	Issue No.	31
LM End	0.17	Issue Type +	Ma	Location *	WS
Category	Earthen Levee			GPS Latitude/Longitude	
				Start	End
Item	Vegetation			38.249449 °	38.247375 °
				-121.510017 °	-121.509990 °
DWR ID	DWR_RD0554_01_f_2016_31				
Comment Code					
V2 : Remove the wild growth other than native grasses from the levee slopes.					
Inspector Comment					
Remove/reduce wild growth on the waterside to 20 feet from the crown.

Looking downstream waterside levee slope from levee mile 0.08-0.30.

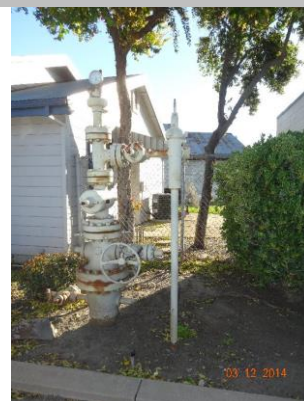
Photo 1 of 1 : UCIP_FA_2018_42146_58463.jpg

LM Start	0.08	Rating **	U	Issue No.	40
LM End	0.08	Issue Type +	En	Location *	
Category	Supplemental			GPS Latitude/Longitude	
				Start	End
Item	DWR UCIP Field Study			38.248643 °	38.248643 °
				-121.509850 °	-121.509850 °
DWR ID	20946				
Comment Code					
Inspector Comment					
FS_ID:42146					
DS_ID:20946					
EP_NO: 5607					
Repair Type: Urgent					
Crossing Status: Indicator Found					
UCIP Comments: No markers. Valves abandoned on landward side--need to contact owner to determine status of crossing.					
FIELD_STRUCT_DESC: Abandoned three 4-inch steel petroleum pipes through the levee, 22.5 feet below the crown. Pipes placed in 8-inch pipe casing through the levee and plugged with concrete. Abandoned under Permit No. 5607 (1966).					
FS Date: 3/12/2014

Valves located on landward side.

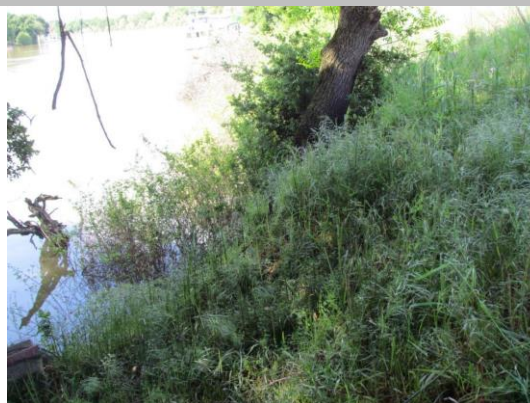
Photo 1 of 1 : FA_2018_RD0554_176_11_20180925_00001.jpg

LM Start	0.10	Rating **	M	Issue No.	11
LM End	0.10	Issue Type +	Ma	Location *	WS
Category	Earthen Levee			GPS Latitude/Longitude	
				Start	End
Item	Erosion / Bank Caving			38.248262 °	38.248262 °
				-121.509901 °	-121.509901 °
DWR ID	DWR_RD0554_01_s_2014_11				
Comment Code					
E1 : Note and monitor erosion site.					
Inspector Comment					
This is not a new erosion site, repairs are needed. One tree has fallen into the Sac River at the erosion site. This site can be seen better from the river by boat. The wild grapes blocks the view from the waterside shoulder looking down the slope. Rated as M because it is an oversized levee section.

RD 554 Waterside levee slope erosion into the bank, the wild vegetation growth blocks the view.

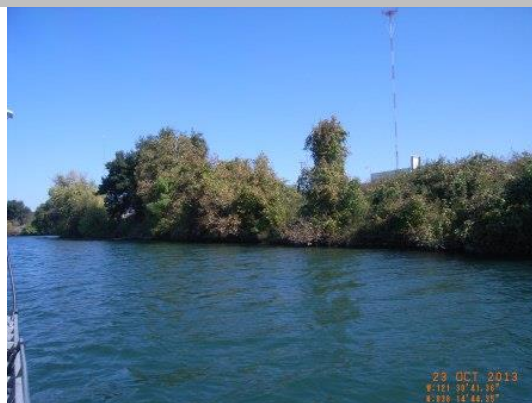
Photo 1 of 2 : FA_2018_RD0554_176_24_20181105_00050.jpg

LM Start	0.26	Rating **	M	Issue No.	24
LM End	0.36	Issue Type +	Ma	Location *	WS
Category	Supplemental			GPS Latitude/Longitude	
				Start	End
Item	2017 USACE Erosion Survey, DRAFT			38.246222°	38.245017°
				-121.510878°	-121.511740°
DWR ID	DWR_RD0554_01_f_2018_24				
Comment Code					
Inspector Comment					
2017 Site ID: SAC 27.0 L					
Status: Eroding					
2017 Field Notes: Minor new erosion at toe.					
Site History: 2009 - Tension cracks on road on top of levee. Erosion into the levee slope and mass failure. 2013 - Short vertical sections at bank toe.

USACE 2013 Photo #1

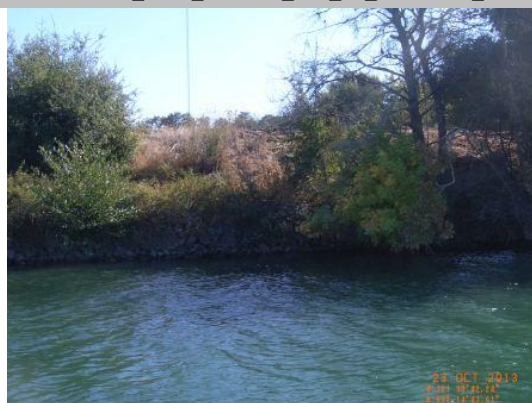
Photo 2 of 2 : FA_2018_RD0554_176_24_20181105_00051.jpg

USACE 2013 Photo #2

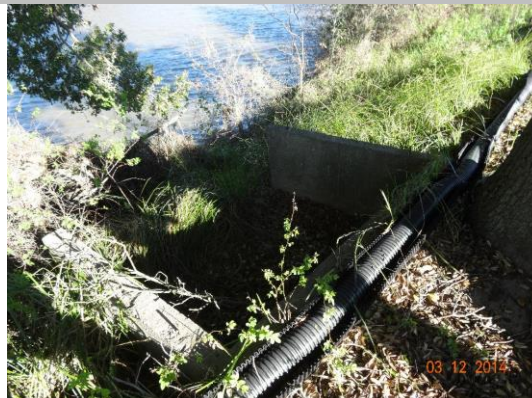
Photo 1 of 3 : UCIP_FA_2018_32018_58469.jpg

Comment Code					
Inspector Comment					
FS_ID:32018					
DS_ID:20897					
EP_NO: N/A					
Repair Type: Non-Urgent					
Crossing Status: Indicator Found					
UCIP Comments: Unable to determine status of crossing--was crossing removed during erosion repair site in 2007-2009? Need to coordinate with LMA or owner to obtain additional information about crossing.					
FIELD_STRUCT_DESC: *ABANDONED* 6-inch irrigation pipe of unknown material through the levee, 1.0-foot below the crown. Concrete pump pad on the waterside (WS) slope. [Additional Reference(s): DWR Levee Log, 1983 and 2005. USACE Sacramento O&M Manual Unit No. 111, May 1959, revised 29 Dec 2016, (River Mile [RM] 27.00)]					
FS Date: 3/12/2014

Concrete U wall located on waterward side.

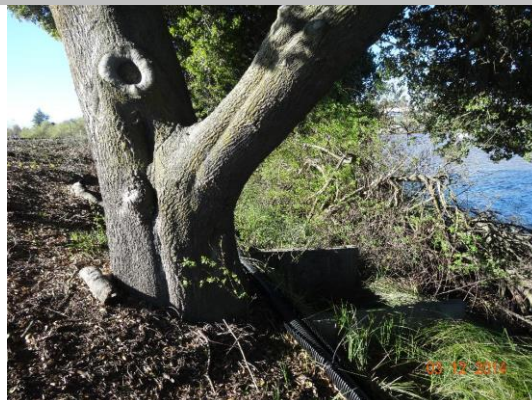
Photo 2 of 3 : UCIP_FA_2018_32018_58468.jpg

Concrete vault located on waterward side. Site is a erosion repair site.

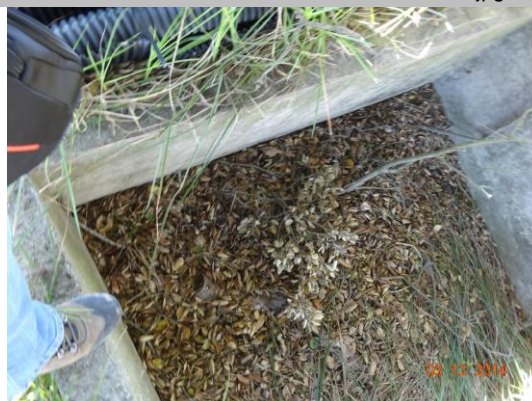
Photo 3 of 3 : UCIP_FA_2018_32018_58467.jpg

Concrete face no outlet visible on waterward side.

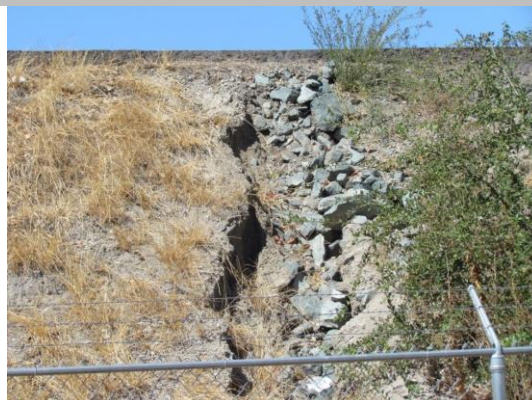
Photo 1 of 3 : FA_2018_RD0554_176_13_20180925_00002.jpg

LM Start	0.32	Rating **	U	Issue No.	13
LM End	0.32	Issue Type +	Ma	Location *	LS
Category	Earthen Levee			GPS Latitude/Longitude	
				Start	End
Item	Erosion / Bank Caving			38.245389 °	38.245389 °
				-121.511085 °	-121.511085 °
DWR ID	DWR_RD0554_01_s_2014_13				
Comment Code					
E2 : Schedule repair of erosion site prior to the next inspection.					
Inspector Comment					
This erosion isn't repaired to date. Large bush growing in eroded gully. Needs repairing.

This erosion along the landside levee slope is not new, it was reported two years ago.

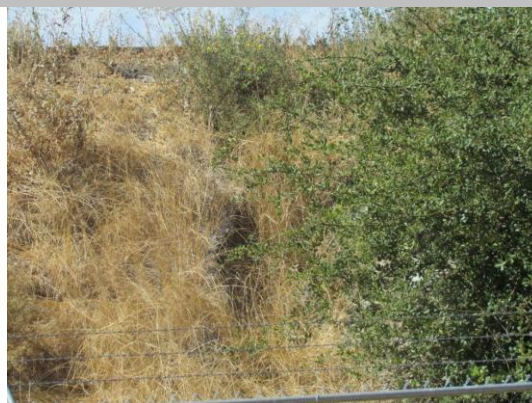
Photo 2 of 3 : FA_2018_RD0554_176_13_20180925_00003.jpg

This erosion site along the landside slope levee 0.32 has been reported and has not been repaired.

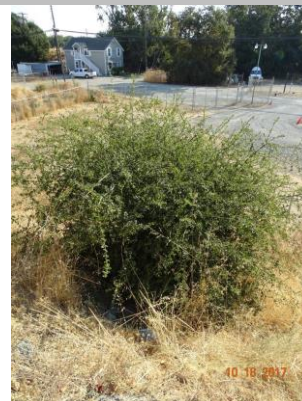
Photo 3 of 3 : FA_2018_RD0554_176_13_20180925_00004.jpg

This erosion is not repaired to date. Large bush growing in eroded gully. Needs repairing.

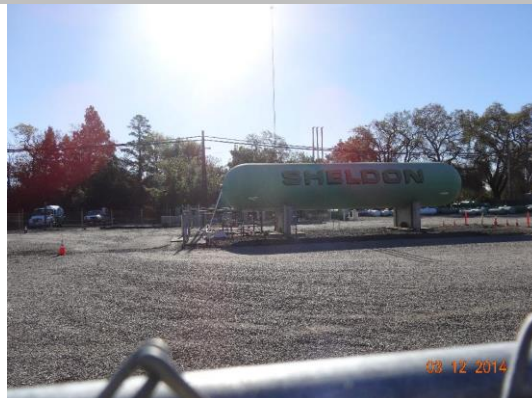
Photo 1 of 1 : UCIP_FA_2018_42143_60800.jpg

LM Start	0.33	Rating **	U	Issue No.	42	
LM End	0.33	Issue Type +	En	Location *		
Category	Supplemental			GPS Latitude/Longitude		
				Start	End	
Item	DWR UCIP Field Study			38.245295 °	38.245295 °	
				-121.511274 °	-121.511274 °	
DWR ID	20922					
Comment Code						
Inspector Comment						
FS_ID:42143						
DS_ID:20922						
EP_NO: N/A						
Repair Type: Urgent						
Crossing Status: Indicator Found						
UCIP Comments: No markers found. Need to contact owner to determine status of crossing. Unable to confirm if crossings are still active or if they cross levee.						
FIELD_STRUCT_DESC: 1 of 3: 3-inch steel fuel line through the levee, 2.7 feet below the crown. (USACE-1959). This entry matches the Drainage or Irrigation Structure referenced in O&M manual (RM 27.20).						
FS Date: 3/12/2014

Tank found on landward side.

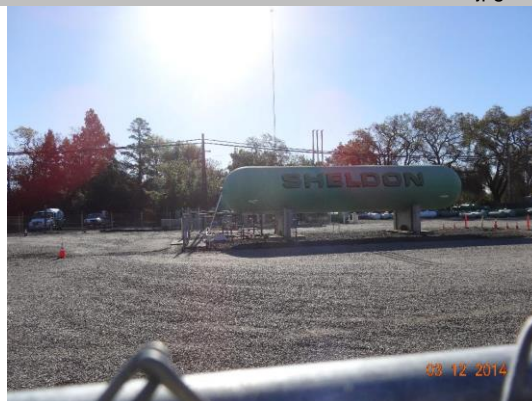
Photo 1 of 1 : UCIP_FA_2018_42144_60801.jpg

LM Start	0.33	Rating **	U	Issue No.	43
LM End	0.33	Issue Type +	En	Location *	
Category	Supplemental			GPS Latitude/Longitude	
				Start	End
Item	DWR UCIP Field Study			38.245295 °	38.245295 °
				-121.511274 °	-121.511274 °
DWR ID	20932				
Comment Code					
Inspector Comment					
FS_ID:42144 DS_ID:20932 EP_NO: N/A Repair Type: Urgent Crossing Status: Indicator Found UCIP Comments: No markers found. Need to contact owner to determine status of crossing. Unable to confirm if crossings are still active or if they cross levee. FIELD_STRUCT_DESC: 2 of 3: 3-inch steel fuel line through the levee, 2.7 feet below the crown. (USACE-1959). This entry matches the Drainage or Irrigation Structure referenced in O&M manual (RM 27.20). FS Date: 3/12/2014

Fuel tank located on landward side.

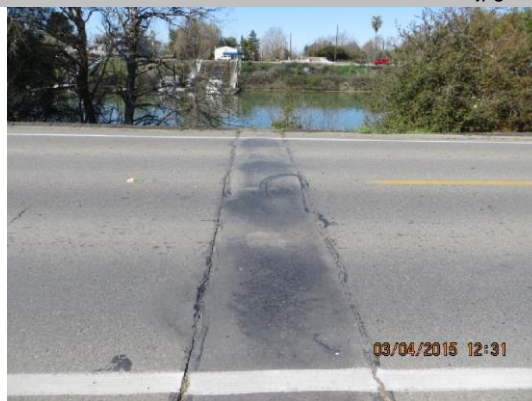
Photo 2 of 3 : UCIP_FA_2018_43694_73221.jpg

Comment Code						
Inspector Comment						
FS_ID:43694 DS_ID:20899 EP_NO: 5429 Repair Type: Non-Urgent Crossing Status: Indicator Found UCIP Comments: Signs of open cut along crossing--no markers visible on waterward or landward side. Large across channel on right bank berm indicating cable through levee. FIELD_STRUCT_DESC: Four 4-inch iron conduits through the levee, at various depths below the crown (3.0-4.9 feet). Each conduit encases a shielded telephone cable. Concrete cutoff wall around pipes on landward levee shoulder. Riser pole off the landward levee toe. (four 5-inch diameter AC ducts through a 18-inch pipe authorized under Permit No. 5429, 1967 - General Telephone Company of California; Replacement telephone conduits were pulled through iron conduits under Permit No. 13417, 1983 - General Telephone Company). [Additional Reference(s): DWR Levee Log, 1983 and 2005] FS Date: 3/4/2015

View of waterside from landside shoulder. Cuts in pavement indicate presence of pipe trench across levee.

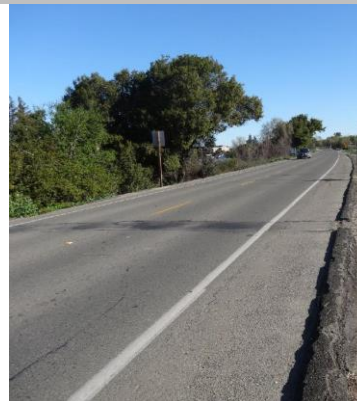
Photo 3 of 3 : UCIP_FA_2018_43694_58062.jpg

Signs of cut through levee at conduit.

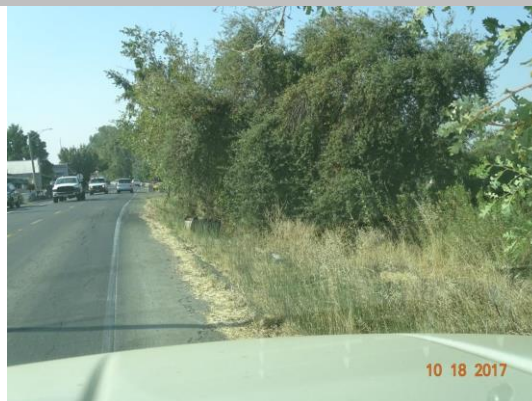
Photo 1 of 1 : FA_2018_RD0554_176_32_20180925_00008.jpg

LM Start	0.36	Rating **	A/W	Issue No.	15
LM End	0.41	Issue Type +	Ob	Location *	WS
Category	Earthen Levee			GPS Latitude/Longitude	
				Start	End
Item	Vegetation			38.244872 °	38.244308 °
				-121.511600 °	-121.512057 °
DWR ID	DWR_RD0554_01_s_2014_15				
Comment Code					
V8 : Environmental Requirements.					
Inspector Comment					
Veg. Site.

Waterside vegetation should be cleared to 20 feet from crown for inspection and access.

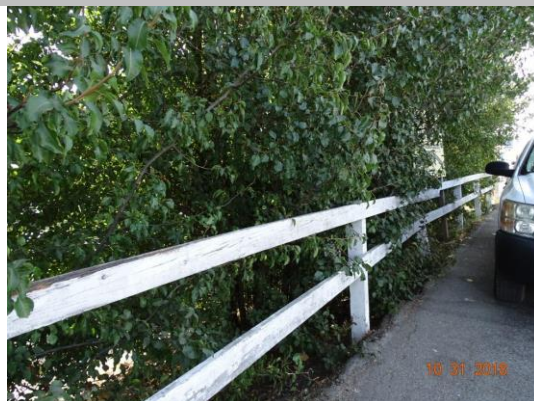
Photo 1 of 1 : FA_2018_RD0554_176_25_20181031_00049.jpg

View of thick trees on the land side slope (October 2018)

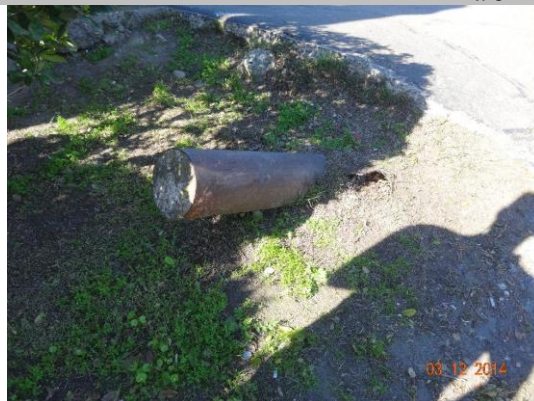
Photo 1 of 1 : UCIP_FA_2018_32020_58473.jpg

Comment Code					
Inspector Comment					
FS_ID:32020					
DS_ID:20912					
EP_NO: 11154					
Repair Type: Non-Urgent					
Crossing Status: Indicator Found					
UCIP Comments: Unable to confirm if this pipe section is the same one listed under 11154. Need to contact owner to determine status and obtain additional information about crossing.					
FIELD_STRUCT_DESC: *ABANDONED* 8-inch pipe of unknown material or purposoe through the levee, 9.8 feet below the crown. Pump on landside (LS) toe. (8-inch pipe retained under Automatic Board Order (ABO) issued as Permit No. 11154, 1975 - M.M. & H.L. Brown, two 4-inch [HLM 0.75]) [Additional Reference(s): DWR Levee Log, 1983 and 2005. USACE Sacramento O&M Manual Unit No. 111, May 1959, revised 29 Dec 2016, (River Mile [RM] 26.66)]					
FS Date: 3/12/2014

Steel pipe filled with concrete visible on landward shoulder.

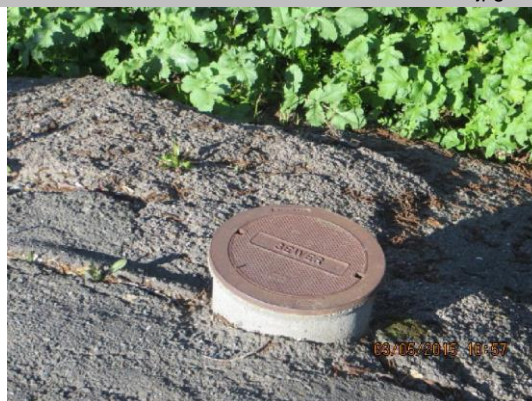
Photo 1 of 3 : UCIP_FA_2018_43805_73320.jpg

FS_ID:43805
DS_ID:25080
EP_NO: N/A
Repair Type: Non-Urgent
Crossing Status: Found
UCIP Comments: No permit found. Further investigation required.
FIELD_STRUCT_DESC: 4-inch cast iron sewer pipe through the levee at an unknown depth. Pipe visible on bridge. Sewer cleanout on waterside (WS) shoulder and cut in pavement visible in roadway. (4-inch pipe authorized under Permit No. 870, 1941 - Shell Oil Company, incorporated)
FS Date: 3/5/2015

Sewer cleanout on WS shoulder.

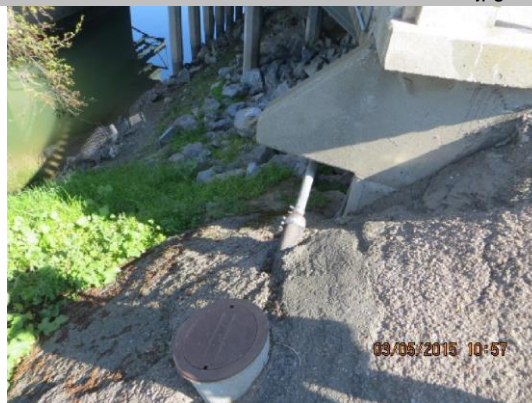
Photo 2 of 3 : UCIP_FA_2018_43805_73321.jpg

Pipe visible at bridge on WS shoulder.

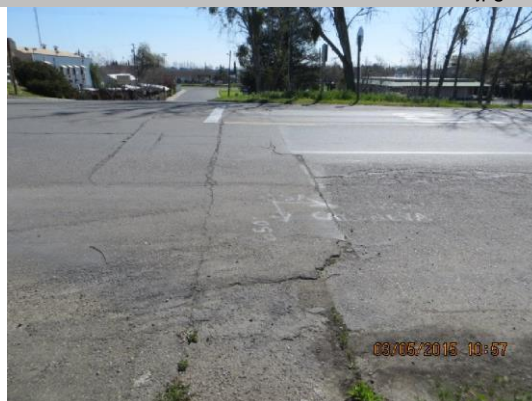
Photo 3 of 3 : UCIP_FA_2018_43805_73322.jpg

Cut in pavement at pipe alignment.

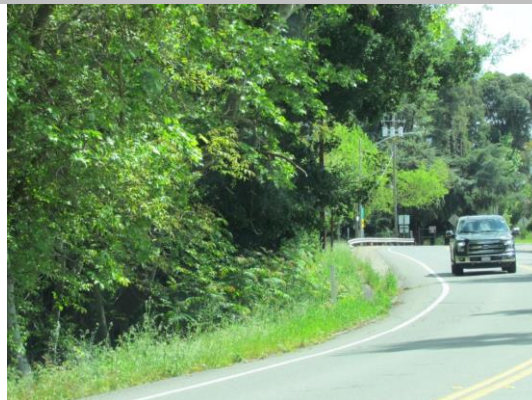
Photo 1 of 1 : FA_2018_RD0554_176_30_20180925_00006.jpg

Looking downstream at the wild growth on the landside levee slope.

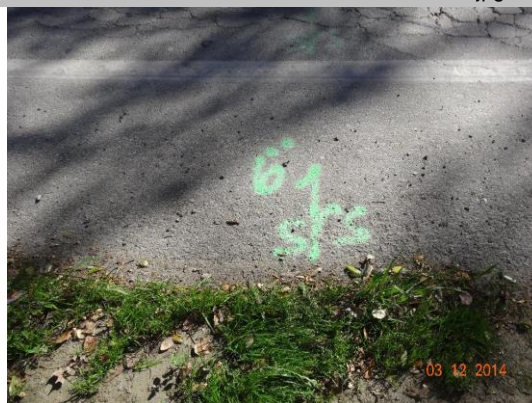
Photo 1 of 3 : UCIP_FA_2018_32021_58475.jpg

LM Start	0.89	Rating **	M	Issue No.	48	
LM End	0.89	Issue Type +	En	Location *		
Category	Supplemental			GPS Latitude/Longitude		
				Start		End
Item	DWR UCIP Field Study			38.238595 °		38.238595 °
				-121.516945 °		-121.516945 °
DWR ID	20941					
Comment Code						
Inspector Comment						
FS_ID:32021 DS_ID:20941 EP_NO: N/A Repair Type: Non-Urgent Crossing Status: Indicator Found UCIP Comments: Unable to confirm how many sewer lines cross levee. Desk study shows 2 crossings 4-inch not 6 inch. Need to contact owner to confirm status of crossing. FIELD_STRUCT_DESC: 1 of 2: 4-inch clay sewer pipe through the levee, 10.2 feet below the crown. (USACE-1959). This entry matches the Drainage or Irrigation Structure referenced in O&M manual (RM 26.50). FS Date: 3/12/2014 2:06:00 PM

Underground service alert (USA) markers confirming sewer line.

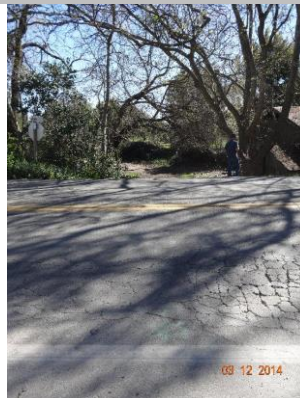
Photo 2 of 3 : UCIP_FA_2018_32021_58474.jpg

View of levee crown.

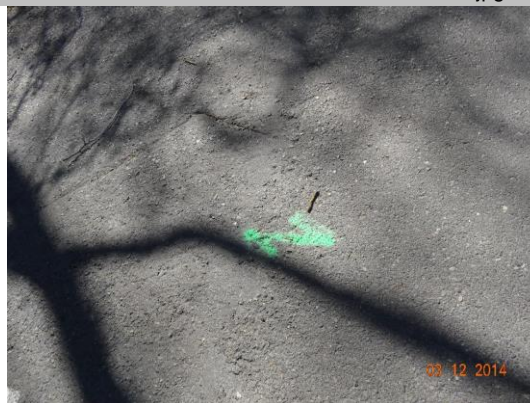
Photo 3 of 3 : UCIP_FA_2018_32021_58477.jpg

View of USA marker on waterward side.

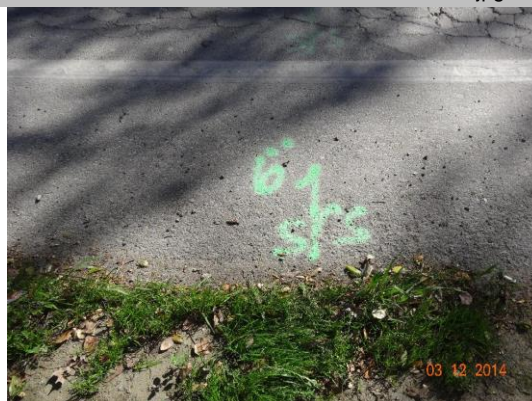
Photo 1 of 3 : UCIP_FA_2018_32022_58480.jpg

LM Start	0.89	Rating **	M	Issue No.	49	
LM End	0.89	Issue Type +	En	Location *		
Category	Supplemental			GPS Latitude/Longitude		
				Start	End	
Item	DWR UCIP Field Study			38.238595 °	38.238595 °	
				-121.516945 °	-121.516945 °	
DWR ID	20942					
Comment Code						
Inspector Comment						
FS_ID:32022 DS_ID:20942 EP_NO: N/A Repair Type: Non-Urgent Crossing Status: Indicator Found UCIP Comments: Unable to confirm how many sewer lines cross levee. Desk study shows 2 crossings 4-inch not 6 inch. Need to contact owner to confirm status of crossing. FIELD_STRUCT_DESC: 2 of 2: 4-inch clay sewer pipe through the levee, 10.2 feet below the crown. (USACE-1959). This entry matches the Drainage or Irrigation Structure referenced in O&M manual (RM 26.50). FS Date: 3/12/2014

Underground service alert (USA) marker on waterward shoulder for sewer line.

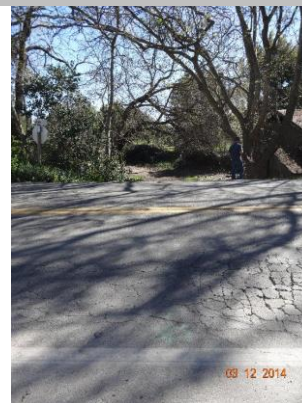
Photo 2 of 3 : UCIP_FA_2018_32022_58479.jpg

View of levee crown.

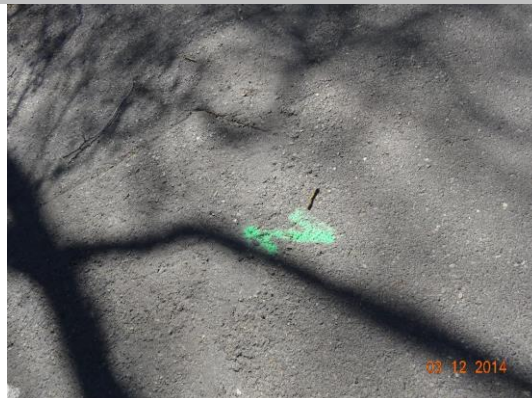
Photo 3 of 3 : UCIP_FA_2018_32022_58478.jpg

View of landward shoulder--USA marker.

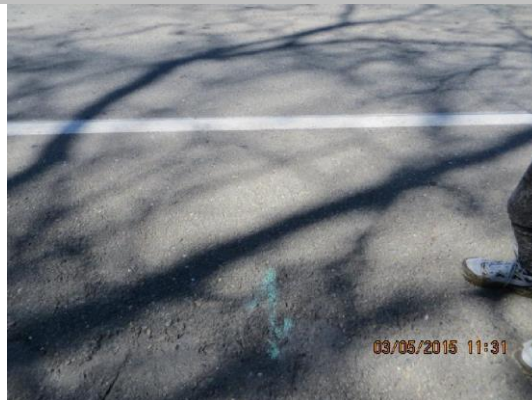
Photo 1 of 3 : UCIP_FA_2018_43804_73323.jpg

LM Start	0.89	Rating **	M	Issue No.	50
LM End	0.89	Issue Type +	En	Location *	
Category	Supplemental			GPS Latitude/Longitude	
				Start	End
Item	DWR UCIP Field Study			38.238510°	38.238510°
				-121.516948°	-121.516948°
DWR ID	25081				
Comment Code					
Inspector Comment					
FS_ID:43804 DS_ID:25081 EP_NO: N/A Repair Type: Non-Urgent Crossing Status: Indicator Found UCIP Comments: No permit identified for crossing. Further investigation required. FIELD_STRUCT_DESC: 6-inch steel sewer pipe through the levee at an unknown depth below the levee crown. USAA markings on pavement indicate crossing at center of ramp on landside (LS) slope. FS Date: 3/5/2015

USAA SS marking on LS shoulder.

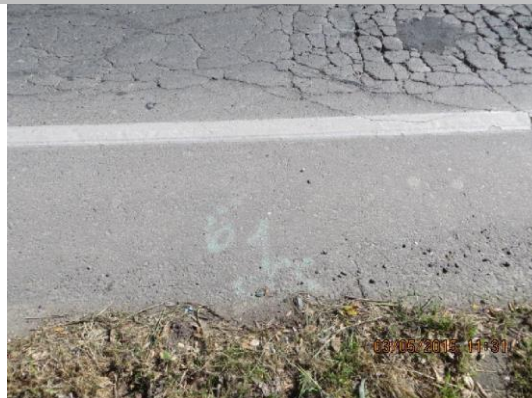
Photo 2 of 3 : UCIP_FA_2018_43804_73324.jpg

USAA SS marking on LS shoulder.

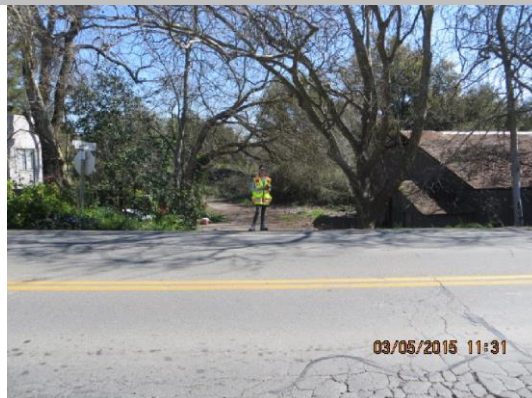
Photo 3 of 3 : UCIP_FA_2018_43804_73325.jpg

Alignment through center of driver on LS shoulder.

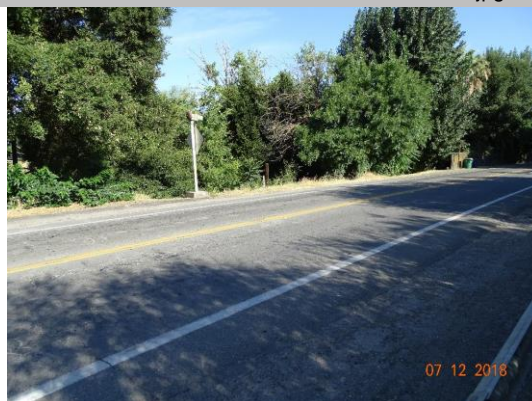
Photo 3 of 3 : UCIP_FA_2018_53406_77593.jpg

Comment Code						
Inspector Comment						
FS_ID:53406 DS_ID:20943 EP_NO: 2321 Repair Type: Non-Urgent Crossing Status: Indicator Found UCIP Comments: 07/12/2018 Dense vegetation on LS. Unable to approach pumphouse at LS toe and evaluate levee condition. Crossing has been downgraded to "Non-Urgent". No integrity issue was observed on levee. (O.Yakimov-DWR UCIP)7/25/2016 Coordinated with District Engineer, Gilbert Labrie with DCC Engineering. He will coordinate with owner. (DWR UCIP - omagana)3/05/2015 Pipe leak at landside toe 23-ft upstream from pumphouse on LS toe. (DWR UCIP - omagana) FIELD_STRUCT_DESC: 1.0-inch steel domestic water pipe through the levee, 1.5 feet below the crown. Shut off valve on the waterside (WS) and at the pump house downstream 170 feet on landside (LS) toe. Pump in pump house on LS toe. An additional 1.5-inch galvanized iron drinking water pipe runs from pump house along LS toe parallel to levee. (0.5-inch pipe authorized under Permit No. 2321, 1957 - Clara B. Salisbury). FS Date: 7/12/2018 7:30:45 AM

View of levee crown at the crossing.

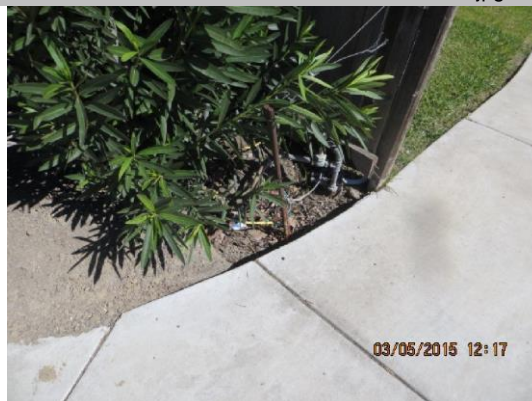
Photo 1 of 3 : UCIP_FA_2018_43810_73328.jpg

Pipes visible at LS shoulder next to driveway.

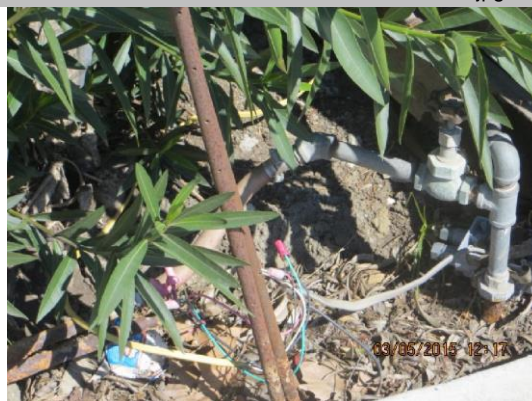
Photo 2 of 3 : UCIP_FA_2018_43810_73329.jpg

Pipes and valves visible on LS shoulder.

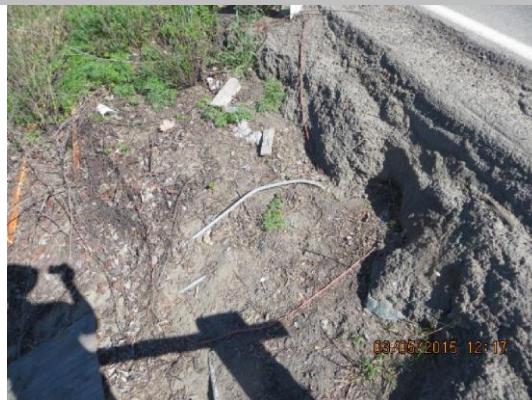
Photo 3 of 3 : UCIP_FA_2018_43810_73330.jpg

Possible outlet on WS shoulder.

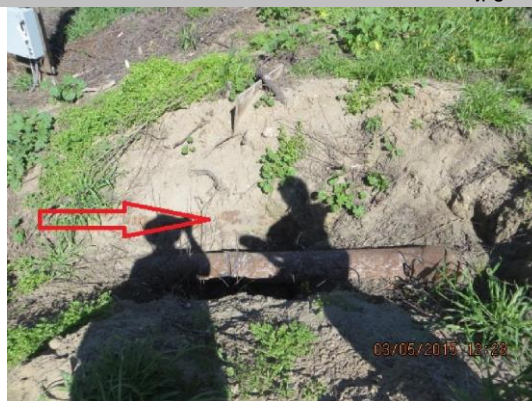
Photo 1 of 1 : UCIP_FA_2018_43747_73286.jpg

Abandoned pipe was exposed on WS slope when a trench was opened to repair the other 8-inch pipe at the site.

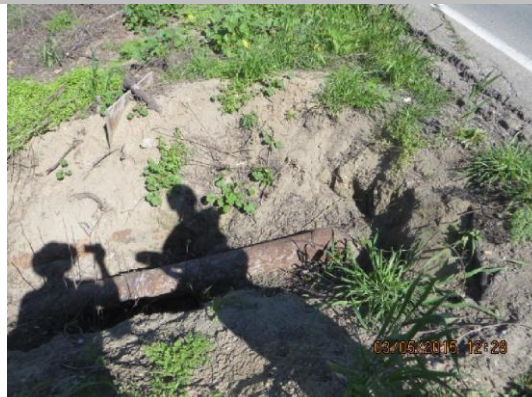
Photo 1 of 3 : UCIP_FA_2018_43748_73289.jpg

Pipe in open trench on WS slope. Repair patch on pipe.

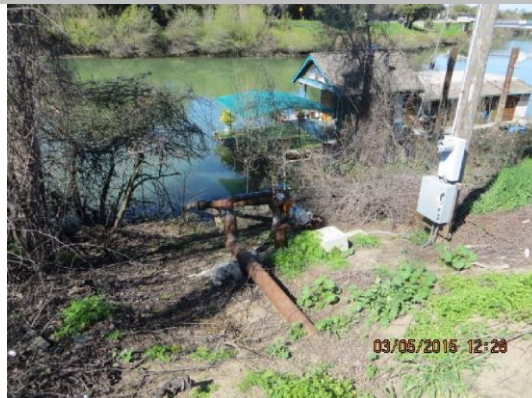
Photo 2 of 3 : UCIP_FA_2018_43748_73288.jpg

Pipe exposed on WS slope. pump, shutoff valve, and meter on pole on WS slope.

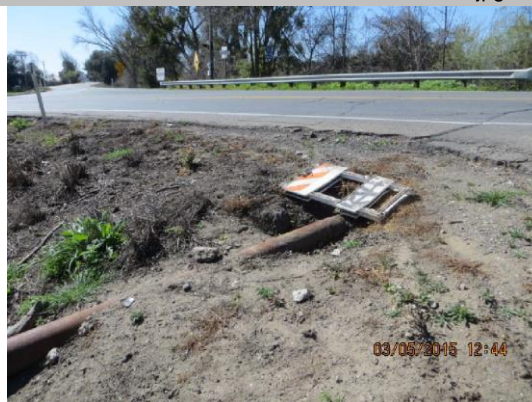
Photo 3 of 3 : UCIP_FA_2018_43748_73287.jpg

Pipe exposed on LS shoulder.
